Report on the overview of the high pressure gas accident

| Reference No. 2012-106 | Name of the accident: Explosion and fire at a resorcinol plant | | |
| Date and time of occurrence: 2:15 am on April 22, 2012 | | Place of the accident: Waki-cho, Kuga-gun, Yamaguchi Prefecture, Japan | |
| Plant name: Resorcinol plant | Equipment name: Oxidation reactor | Main structural material: JIS SUS304L / JIS SM490B clad | Summary of dimensions(mm): Inner diameter 5,150 TL 12,000 |

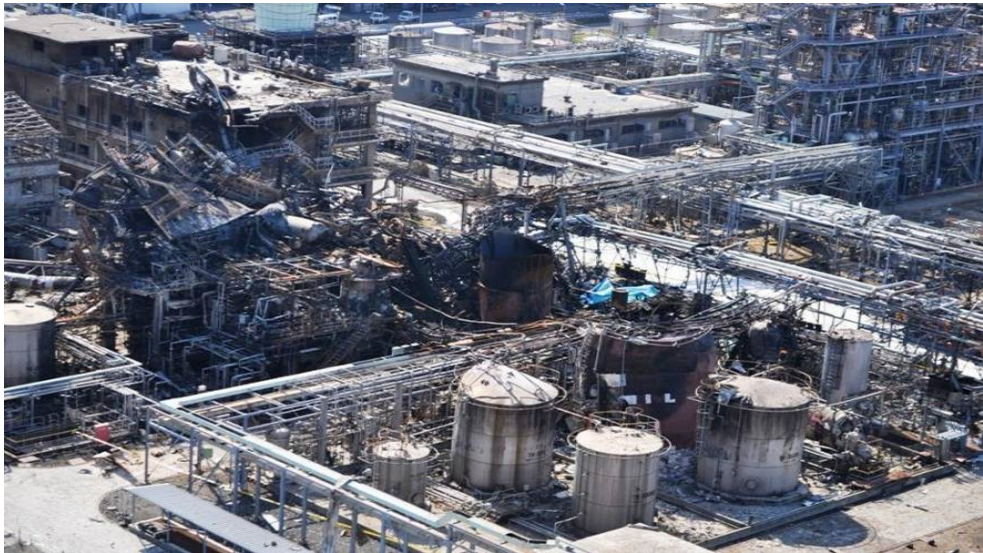
Photo 1 View of accident site

| Damage situation: (Photo 1) <p>A problem arose with the steam generating plant and all plants the steam was supplied to were being put through emergency shutdowns one by one when the dihydroxy peroxide (DHP) inside the oxidation reactor in the resorcinol plant (Fig. 1) decomposed. The temperature and pressure inside the oxidation reactor rose rapidly and the oxidation reactor burst (Figs. 2, 3), causing an explosion and fire. There was a second explosion at the same reactor. One employee who was working near the oxidation reactor at the time of the first explosion was killed, and 25 people including local residents were injured. Additionally, 999 buildings and homes in the surrounding areas were damaged. (Fig. 4, 5) (Based on final report from the company)</p> | | | |

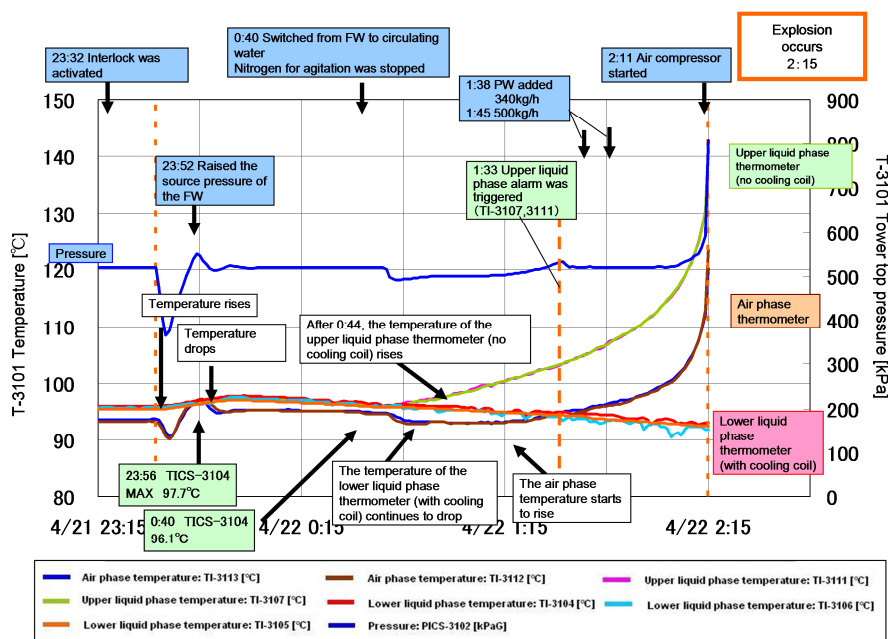
Fig. 6 Operation condition up to the explosion and fire and temperature and pressure trends

1. There was insufficient capability for cooling the oxidation reactor in the event of an emergency shutdown.
2. Conditions for releasing the interlock were not clearly defined.

3. The thermometer for the interlock was set only in the lower part of the oxidation reactor and not in the upper part.
4. It was not easy to notice abnormalities during emergency shutdown just by looking at the DCS screen (Did not show nitrogen flow rate, temperature distribution in the oxidation reactor, and relationship between positions of the thermometers and the indicated temperatures) and the alarms were not appropriate (Not triggered when gas for agitation is stopped).

1. Ensure the necessary capability for cooling the oxidation reactor in the event of an emergency shutdown.
2. Clarify the conditions in which the interlock may be released.
3. Install thermometers at multiple points in the oxidation reactor.
4. Create DCS screen and review alarms to ensure operators can easily notice abnormalities during emergency shutdown.
5. Prepare educational materials and conduct training regarding interlocks.
6. Review the operation procedure in the event of an emergency shutdown of the oxidation reactor and review equipment risks.
