Report on the overview of the accident

Reference No. -		Name of the Accident: Explosion and fire at an acrylic acid production facility.		
Date and time of occurrence: Around 14:35 on September 29, 2012		Place of the accident: Himeji-city, Hyogo Prefecture, JAPAN		
Plant name: Acrylic acid production facility	Equipment name: Intermediate tank (V-3138)	Main structural materials: Side plate: JIS SUS304 (t 3mm) Bottom plate: JIS SUS316 (t 4mm)	Summary of dimensions: Inner diameter 4.2m Height 5.6m (Thermal insulation installed)	
Contents: Acrylic acid, Inhibitors, etc.	Nominal capacity: 70m ³	Normal operating pressure: Atmospheric pressure	Normal operating temperature: Not defined	
Damage situation: An intermediate tank (V-3138, Fig. 1) temporarily stored the bottom liquid of the glacial acrylic acid rectifying column in the acrylic acid production facility ruptured and exploded causing a fire in the surrounding area, which damaged an adjacent acrylic acid tank, a toluene tank, racks, piping, etc.(Fig. 2) In this accident, 1 person (a fire fighter) was killed, 5 were severely injured (2 fire fighters, 3 employees), 13 were moderately injured (8 fire fighters, 1 police officer, 4 empl

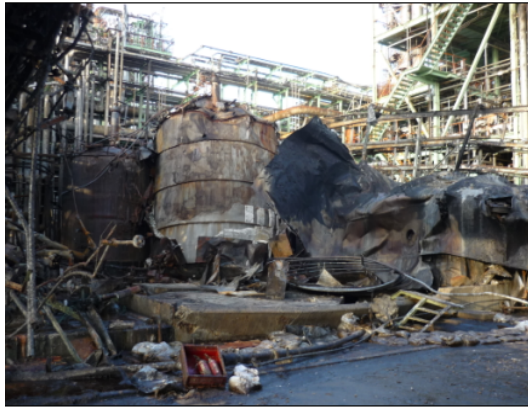
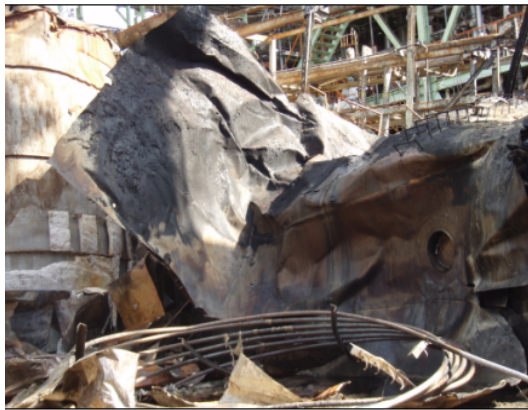
Fig.2 Damaged Tank
(View from southwest and zoom in)

1. The roof plate broke and separated near the roof-to-shell joint. The roof plate has split into two and being thrown to a distance of about 50m (see Fig. 3).
2. The shell plate was vertically torn in a near straight line at 270° position and deformed into casement-type opening and left almost like a flat plate within the dike at the accident site. The bottom plate partly broke near the shell-to-bottom joint and remained inside the dike.
3. The cracks formed around the outlet nozzle of cooling water coil propagated and split the tank shell plate vertically in both directions at 270° position. The upwards crack broke into the roof plate and ran through it near the 135° position. The roof and bottom plates generally cracked in the circumferential direction near their joints with the shell plate.

3. The abnormal condition was not possible to recognize due to the lack of thermometers and inadequate temperature monitoring, until the polymerization reaction of acrylic acid had proceeded. As a result, V-3138 exploded, followed by fire and caused enormous casualties and property damages (see Figs. 2 and 5).

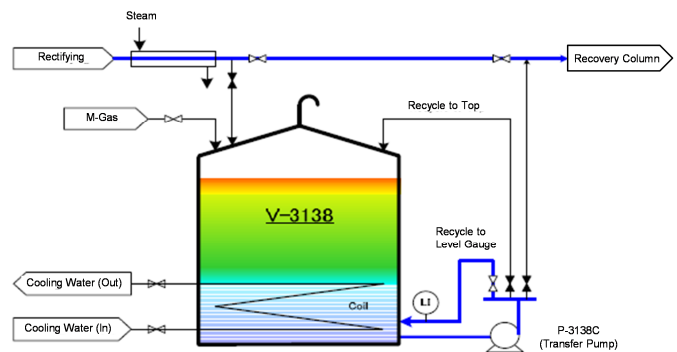
Fig.4 Status of tank V-3138 after liquid storing

1. Even though high temperature T-5108 bottom liquid was building up in the intermediate tank (V-3138), the fact that the circulation of recycle to top was not commissioned has caused acrylic acid to remain stagnant for a significant long period of time at high temperature in the upper portion of the tank (Fig. 4).

2. Dimer formation of acrylic acid accelerated in the tank liquid with high temperature zones and the liquid temperature in the storage tank was elevated by the heat of dimerization. As a result, the polymerization reaction of acrylic acid starts to proceed and increased the liquid temperature further.

1. Measures to prevent recurrence for equipment causing the accident
 - (1) To prevent excessive heating in the tank feed liquid, specification of the T-5108 bottom liquid transfer pipe should be changed.

- (2) To control the appropriate temperature of the stored liquid in V-3138, specifications of the intermediate tank (V-3138) and (new) associated equipment should be studied. The criteria and its response procedure for the abnormal status should be clarified.
