Report on the overview of the high pressure gas accident

Reference No.	Name of the accident:				
2011-386	Explosion and fire at vinyl chloride monomer production plant.				
Date and time of occurrence:				Place of the accident:	
Around 15:15 on November 13, 2011				Shunan-city, Yamaguchi Prefecture, JAPAN	
Plant name:		Equipment name:		Main structural	Summary of dimensions (mm):
Vinyl chloride monomer		1.	Hydrochloric acid	materials:	1. Overall length 28,000 ^{TL}
production plant unit 2			removal column	1. JIS SLA325A,	Upper stage 1,900 ^{ID} x 11,600 ^{TL}

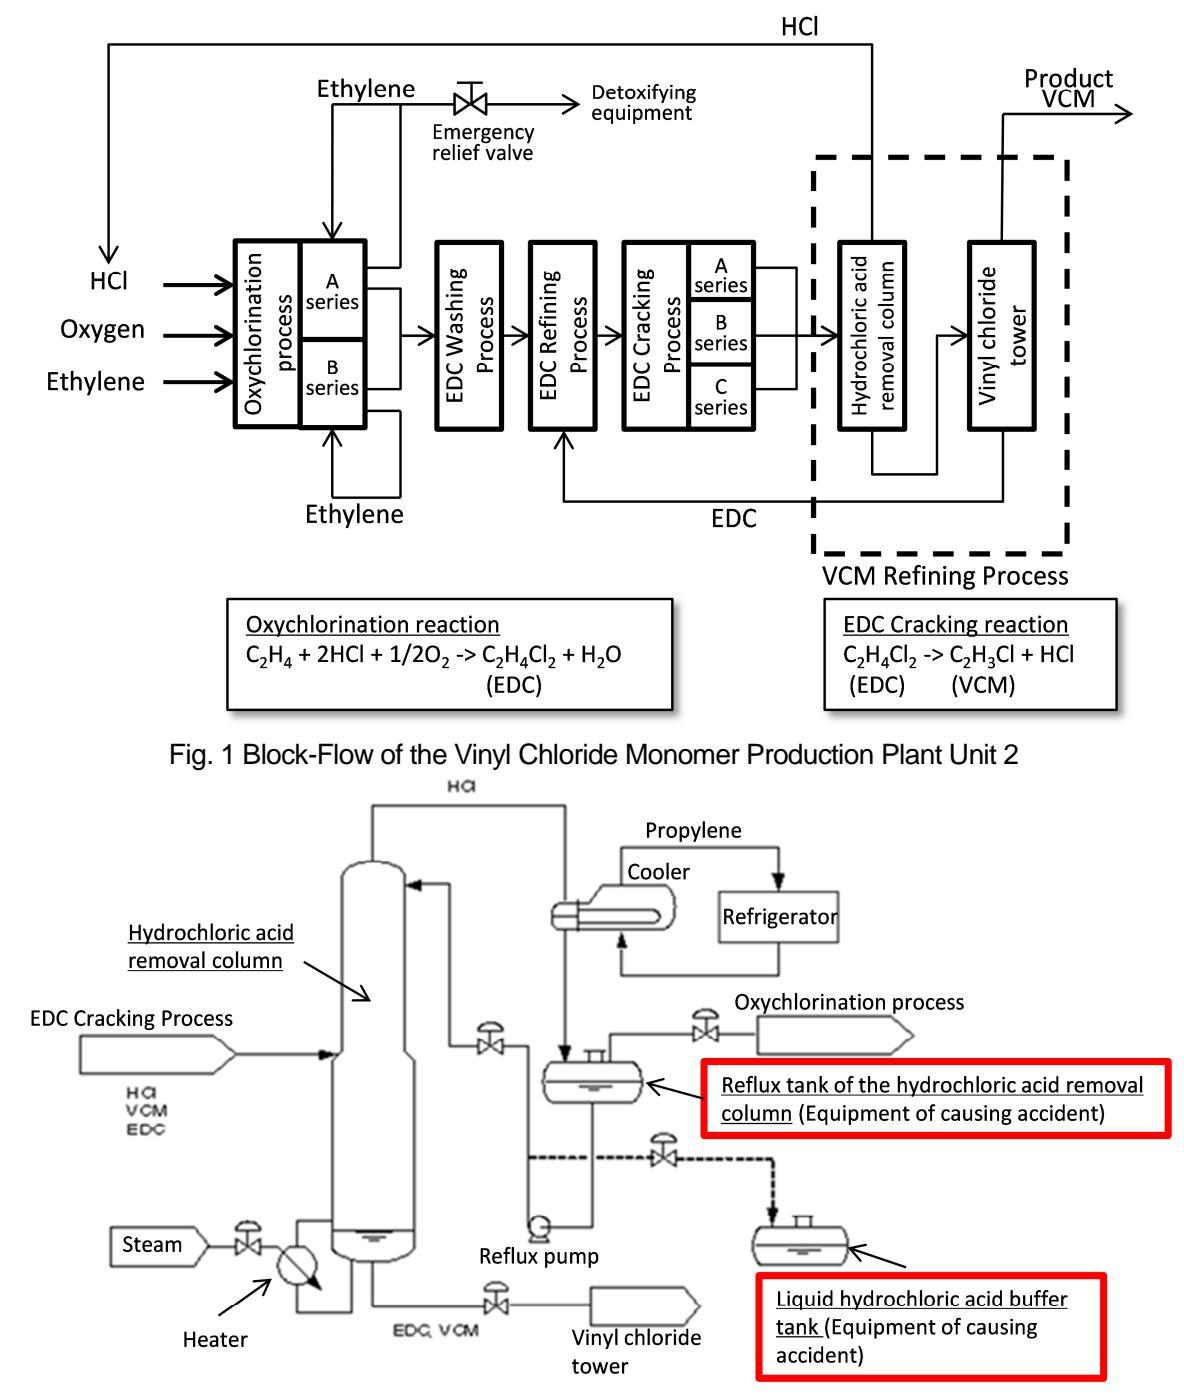
Fig. 2 VCM Refining Process - Flow Sheet around the Hydrochloric Acid Tower

- 2. Explosion of the reflux tank of the hydrochloric acid removal column
- It was found that the explosion was caused by the fact that 1, 1-ethylene dichloride (1, 1-EDC) is easily generated by a reaction between HCl and VCM in the presence of Lewis acid catalysis such as iron chloride (III) (FeCl₃).

- HCl and VCM were found mixed within the reflux tank of the hydrochloric acid removal column and the liquid hydrochloric acid buffer tank, and FeCl₃ was generated by the reaction of iron rust in a vapor phase portion on the inner wall with HCl. Then the reaction to generate 1,1-EDC progressed with FeCl3 as the catalyst. Subsequently, the abnormally high temperature at the column top of the hydrochloric acid removal column was noted based on the trend data on the Distributed Control System, reminding the operators of the possibility of the mixture of VCM in the reflux tank of the hydrochloric acid removal column. Since the generation of 1,1-EDC could not be assumed, normal instructions to stop the operation in accordance with the manual of the hydrochloric acid removal column were given.

- This reaction is accompanied by an increase in temperature due to an exothermic reaction and the reaction speed gets exponentially faster with the rise in temperature. Then, it is presumed that the pressure within the reflux tank of the hydrochloric acid removal column increased rapidly allowing combustible fluid to leak from the liquid hydrochloric acid buffer tank, and the reflux tank of the hydrochloric acid removal column burst resulting the explosion of leaking VCM and 1,1-EDC induced by an unidentified ignition source.

- 1. Equip the hydrochloric acid removal column with an interlock system, which shut down not only both of the cracking process and the oxy chlorination process but also the steam to the heater of the hydrochloric acid removal column, in case a plurality of thermometers at the column top record abnormally high temperatures. In addition, it must be clearly stated in the operation manual that, when starting shut down process of the hydrochloric acid removal column due to an anomaly in the column top temperature, a full reflux operation should be performed, and then it shall be stopped after checking the column top temperature becoming -24 °C as in the normal condition.

- 2. To the Distributed Control System, add alarms for notifying that the pressure of the reflux tank of the hydrochloric acid removal column is different from the vapor pressure of the HCl alone due to the mixture of VCM into the reflux tank of the hydrochloric acid removal column, and also add indications of changes in temperatures and pressures per a unit of time.

- 3. Eliminate residues of iron rust on the inner wall when the reflux tank of the hydrochloric acid removal column and the liquid hydrochloric acid buffer tank have been opened for periodic maintenance, and make sure of their complete elimination by comparing with the finish photos attached to the work specifications.

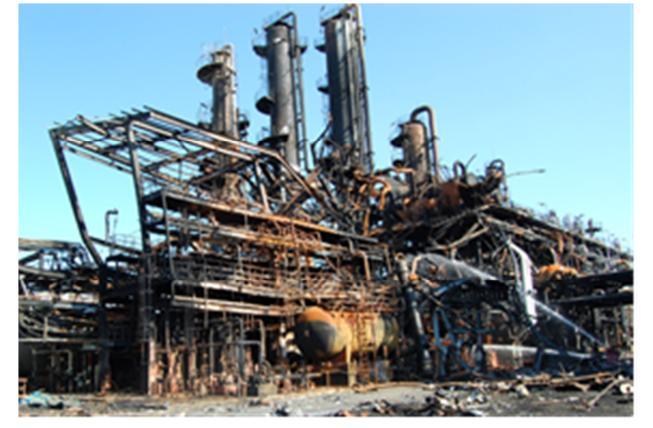
- 11. At around 15:23, the pressure of the reflux tank of the hydrochloric acid removal column increased to over 2.0MPaG.
- 12. At 15:24, the reflux tank of the hydrochloric acid removal column burst and exploded, and a wide area of the vinyl chloride monomer production plant unit 2 burst into flames.

Photo 1 Overall Damage View

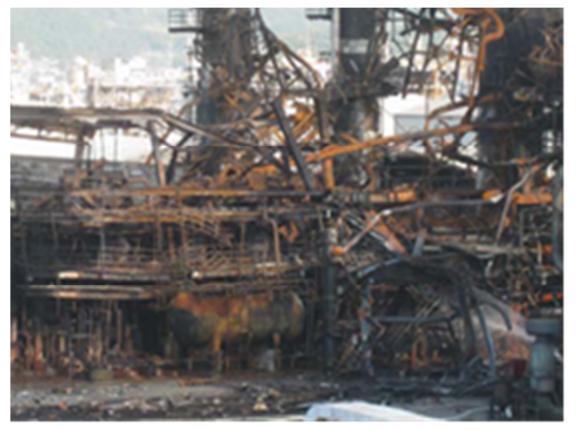
Photo 2 Magnification of Photo 1
