Report on the overview of the high pressure gas accident

| Reference No. 2012-106 | Name of the accident: Explosion and fire at a resorcinol plant | | |
| Date and time of occurrence: 2:15 am on April 22, 2012 | | Place of the accident: Waki-cho, Kuga-gun, Yamaguchi Prefecture, Japan | |
| Plant name: Resorcinol plant | Equipment name: Oxidation reactor | Main structural material: JIS SUS304L / JIS SM490B clad | Summary of dimensions(mm): Inner diameter 5,150 TL 12,000 |

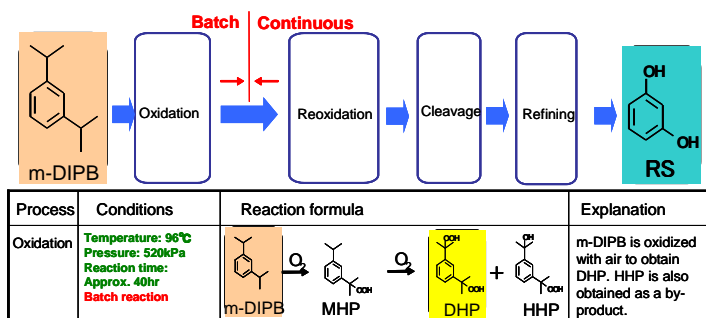
Material-1 Resorcinol plant block flow and reaction formula

of gases due to these two processes generated pressure that exceeds the burst pressure and resulted the rupture. (Material-2)
